Survey Point **ROCK FALLS 01**  Northing 1859921.67 Easting 2414069.39

Location:

Along the North side of Rt. 30 on the ROW line between 3920 W. Rock Falls Rd. (Rt.30, The underground House) and Rock River Provision. 837.8' W. of the intersection of Rt. 30 and Riverdale Rd. and 36.2' N of the W bound lane pavement.

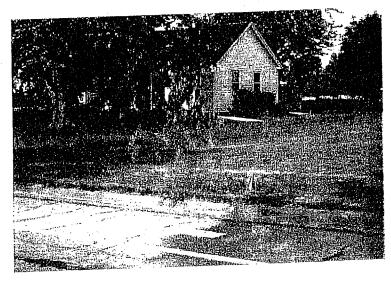
Survey Point ROCK FALLS 06

Looking West at house 1710 Buell Rd. (14th Ave.)

On 14<sup>th</sup> Ave. between w 17<sup>th</sup> St. and 19<sup>th</sup> St. on the West side of 14th Ave. behind the curb line. 3' W of the S bound curb \*(BoC) on Buell Rd. (14th Ave.) and 50' North of the NE corner of house 1710 Buell Rd. (14<sup>th</sup> Ave.)

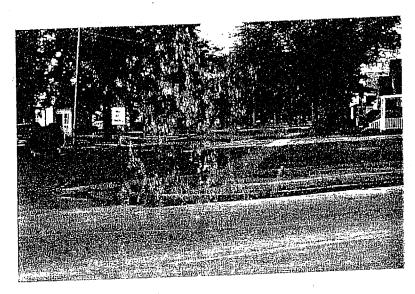
Survey Point ROCK FALLS 08 Northing 1862331.77 Easting 2424473.53 Elevation (US feet) 638.72

Looking South down 7th Ave.

In the intersection of W 2<sup>nd</sup> St. and 7<sup>th</sup> Ave. on the SW corner of W 2<sup>nd</sup> St. and 7<sup>th</sup> Ave. 8.6' S of the S edge of the curb line \*(BoC) of W 2<sup>nd</sup> St. and 16.0' W of the W curb edge \*(BoC) of 7<sup>th</sup> Ave.
